**INFLUENCE OF HULL CONFIGURATION AND VESSEL  
PROPULSION SYSTEMS ON SEA TURTLE SHELL  
INJURIES**

A Thesis  
Presented to  
The Academic Faculty

In Partial Fulfillment  
of the Requirements for the Degree  
Doctor of Philosophy in the  
School of Civil and Environmental Engineering

Georgia Institute of Technology  
August 2012

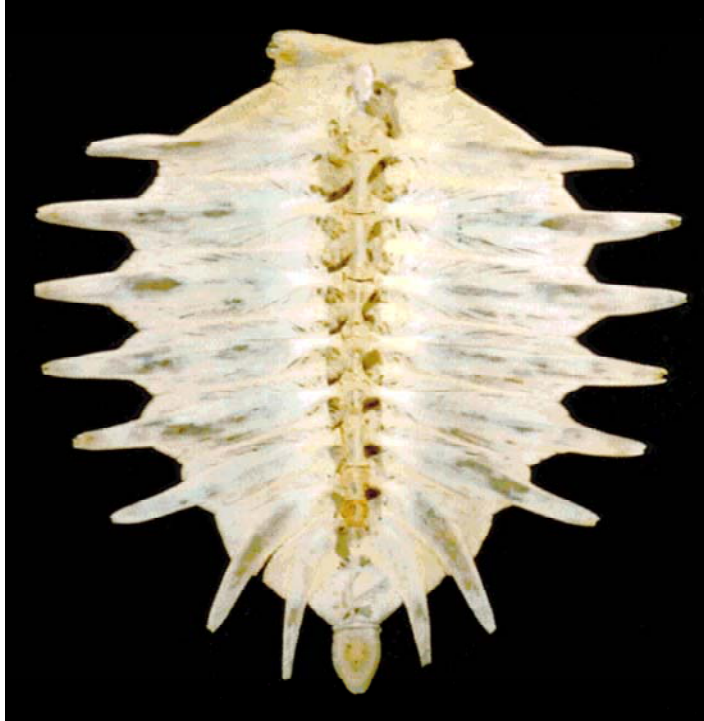
The bones that compose the shell ossify in the dermis, the deep layer of the skin. A row of central (neural) scutes cap the neural spines of the dorsal vertebrae, and a lateral row of costal scutes is directly connected with the dorsal ribs, as shown in Figure 2.2.

Figure 2.2. The carapace in ventral view, showing the close association of the ribs with the costal plates (Rieppel 2001)

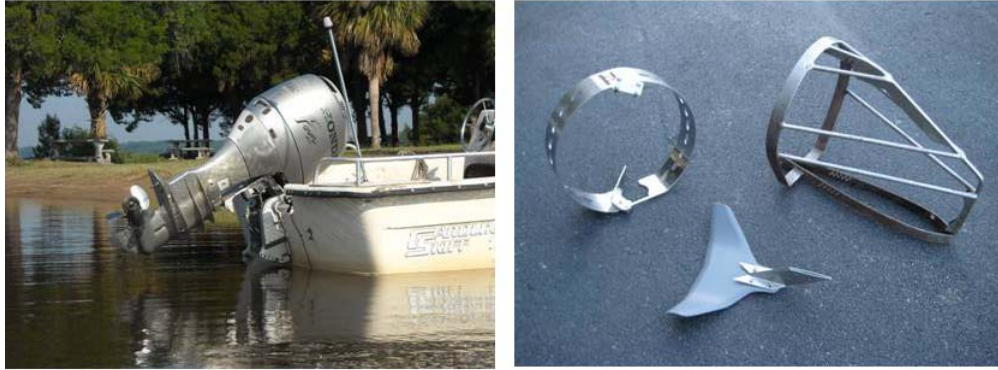
The work in Phase II (Sapp 2010; Work et al. 2010) produced synthetic shells to use in field testing to determine the influence of vessel speed, animal position in the water column, and vessel propulsion system on the lethality of vessel collisions on turtles. The speeds considered were idle (7 km/h), sub-planing (14 km/h), and planing (40 km/h). The two animal positions in the water column were at the water surface and at propeller depth. The engine types were a standard outboard motor with and without commercially available prop guards, and a jet-propulsion outboard motor. The artificial carapace design was constructed of two layers of fiberglass and polyester resin separated by a nonwoven fabric spacer. The presence of catastrophic injury was dependent on both vessel speed and propulsion type. The jet propulsion drive presented significantly lower risk of a fatal injury. The propeller guards shown in Figure 2.4 were ineffective at mitigating damage due to vessel strikes, and the position of the turtle in the water column did not directly affect the probability of injury.

Figure 2.4. Outboard propeller and guards used during Phase II field testing (Sapp 2010)

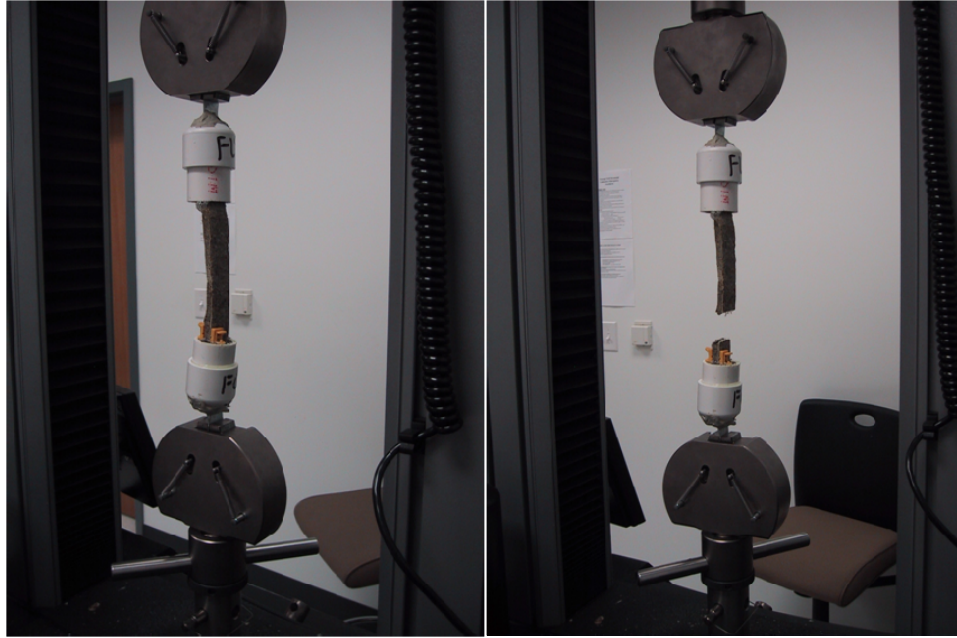
constructed from 3.18 cm PVC cap and pipe with a steel hook inserted in the end, as shown in Figure 3.1. Samples were then embedded in epoxy, and the steel tabs were placed in the grips during testing. A carapace specimen is shown during testing and after fracture in Figure 3.2. A total of 31 samples were tested from a single loggerhead carapace.

Figure 3.2. Organic specimen in tabs during testing and after failure

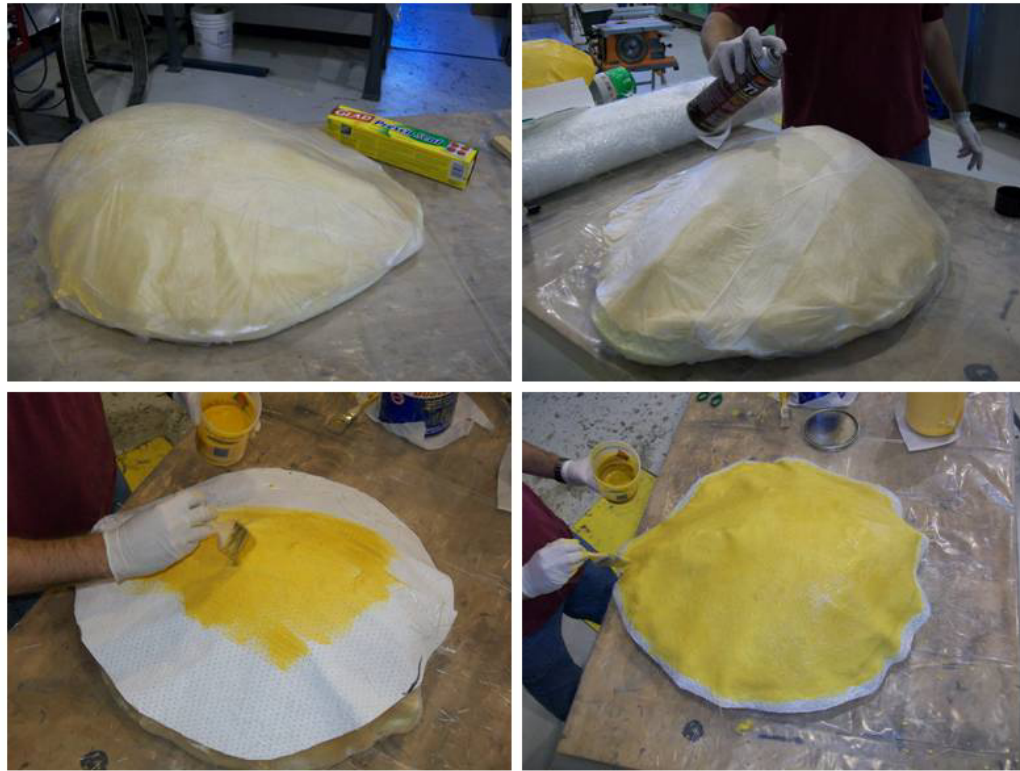
In this phase of the research program (Sapp 2010; Work et al. 2010), artificial carapaces were designed for use in field tests to determine the effects of animal position in the water column, vessel speed, and engine type on sea turtle mortality. The material design consisted of two layers of 229 g/m<sup>2</sup> fiberglass mat in polyester resin separated by a layer of 2 mm nonwoven polyester fabric spacer. The spacer was used to add flexural rigidity by increasing the distance between the stronger fiberglass mat layers, resulting in a higher moment of inertia. This design increased the rigidity of the synthetic carapace as a whole while keeping the force per unit width at failure close to the target value of 408 N/cm. An internal rib structure was also added to the layer on the underside of the carapace to improve its structural rigidity without modifying the tensile strength significantly. The fabrication process is shown in Figures 3.3 and 3.4. The fiberglass carapace was attached to a PVC frame with a series of plastic cable ties, as shown in Figure 3.5.

Figure 3.3. Phase II fiberglass shell manufacturing process (Sapp 2010)

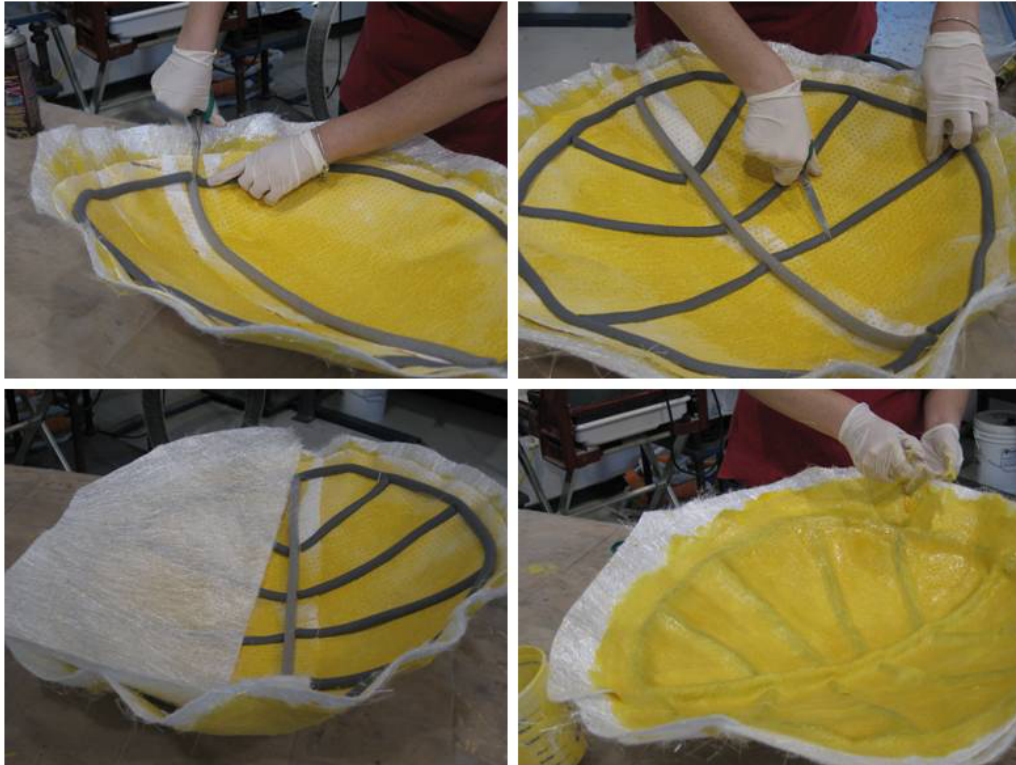
Figure 3.4. Underside of Phase II fiberglass shell with rib layout (Sapp 2010)

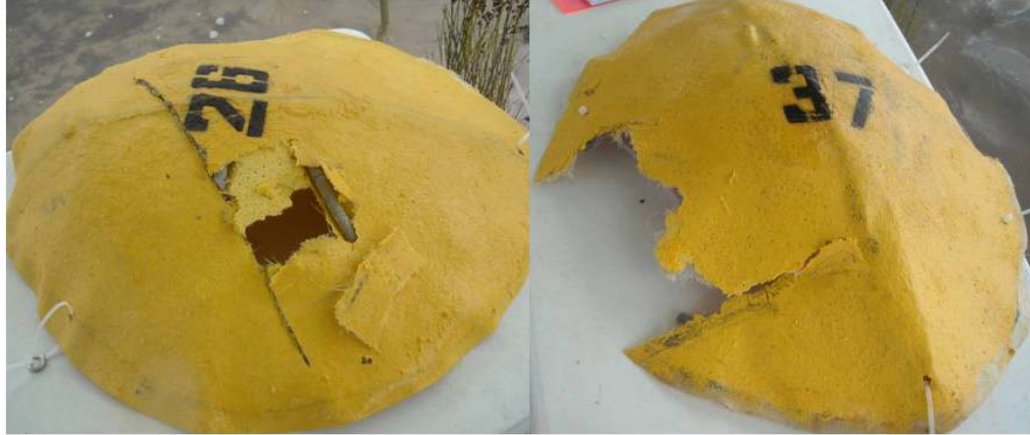
Although the synthetic shell design used in Phase II of the current program approximated certain tensile properties of the loggerhead carapace reasonably well, the failure modes during field testing showed marked differences from actual vessel strike incidents. Namely, the impact of the skag seems to crush the real turtle carapace, while the synthetic shells showed much more deformation and larger damaged areas, as shown in Figure 3.6. The propeller wounds observed during Phase II field tests showed a series of parallel slicing wounds as expected; however, tearing in the shell perpendicular to the line of impact of propeller blades also occurred, as noted on Figure 3.7.

Figure 3.6. Damage to fiberglass shell from blunt impact of skeg from Phase II field tests (Sapp 2010)

Both these discrepancies may be due to the synthetic shell's higher overall flexibility, as well as the shell and frame assembly being less rigid than a live turtle. There also existed some energy dissipation during impact as the shell was allowed to move relative to the frame when the plastic tie attachments were broken. These mechanisms may have allowed a longer time of impact, affording the shell more time to

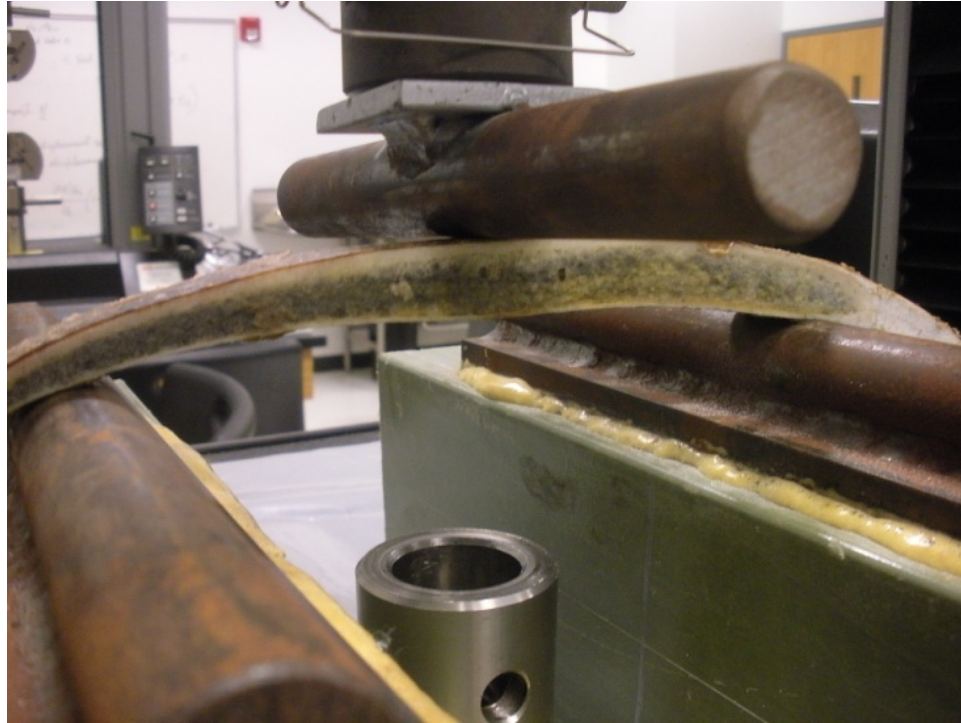
The flexural samples presented problems with their curvature and irregular shape over the supports, as shown in Figure 3.9. The curved samples deflected significantly at the beginning of the test as the ends compressed against the supports and the sample flattened under the initial load. Once the sample lay flat between the supports, its

Figure 3.9. Flexural testing of carapace specimen before application of load

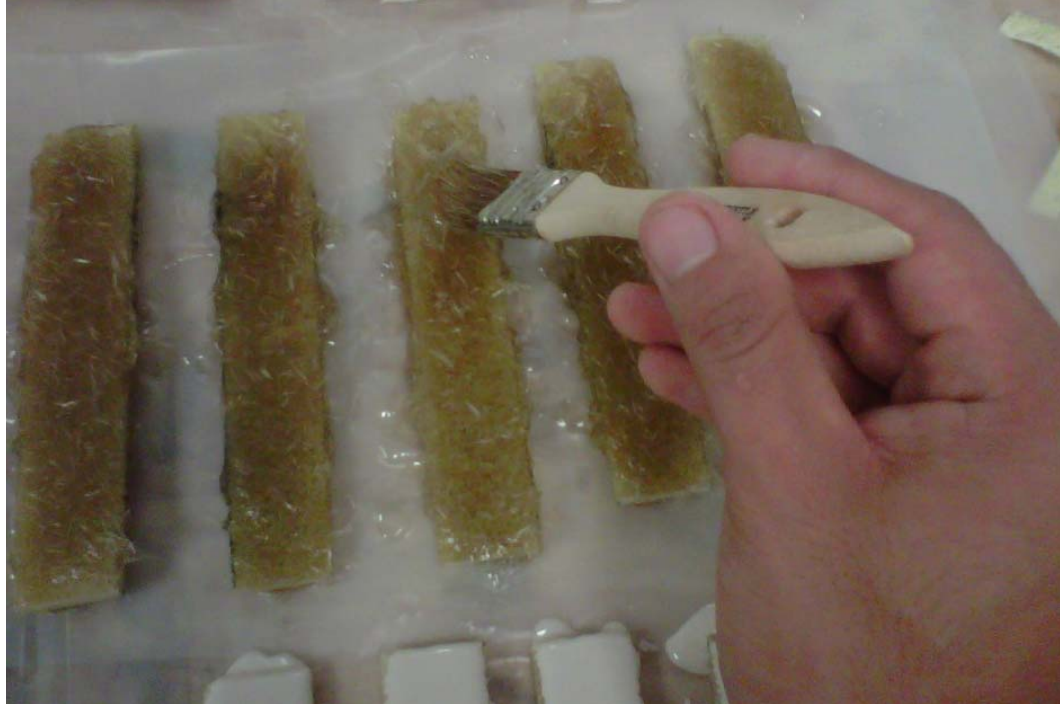
The urethane foam was prepared by combining two components in equal volume and mixing for forty-five seconds. The mixture was poured into a rectangular container and allowed to expand and harden. Rectangular coupons approximately 2.5 cm wide and 0.7 cm thick were prepared with a hand saw. The surface materials were then applied by hand, as shown in Figure 3.11.

Figure 3.11. Application of resin and glass fibers to foam coupons

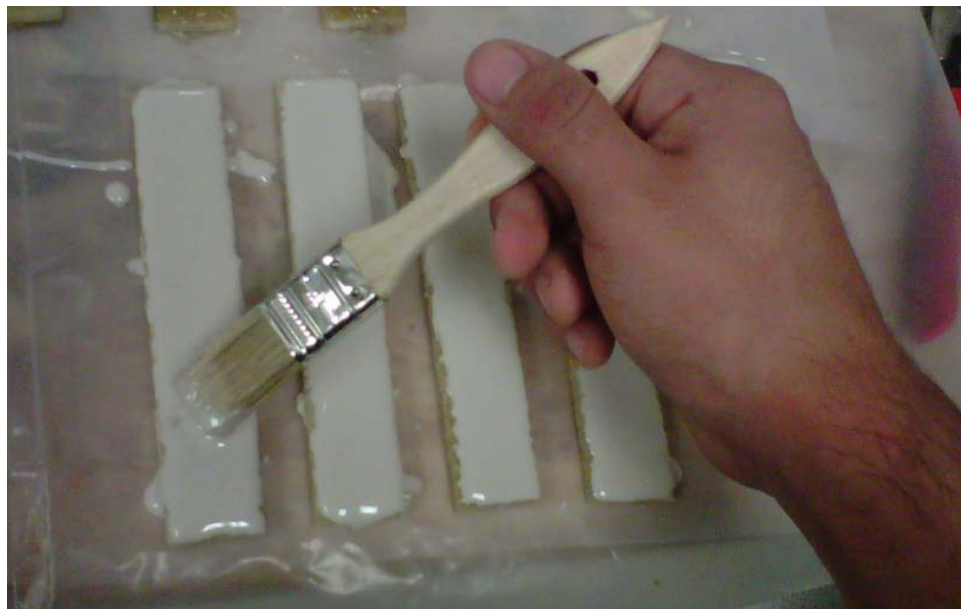
The 256 kg/m<sup>3</sup> foam core with faces of polyester resin infused with glass microspheres (16FPGB-2(2)), shown in Figure 3.12, was chosen as the material system. The choice was based on the material properties from tensile testing and other factors. The tensile properties were similar to those of the organic samples tested by Hodges (2008) with the exception of the elastic modulus; the target value was 312 MPa, and the material system's was 200 MPa. A typical stress-strain curve is shown in Figure 3.13. Organic materials have a large variability in material properties, however, and the target property was based on the testing of only one loggerhead carapace. Furthermore,

Figure 3.12. Application of polyester resin with glass microspheres to rectangular coupons

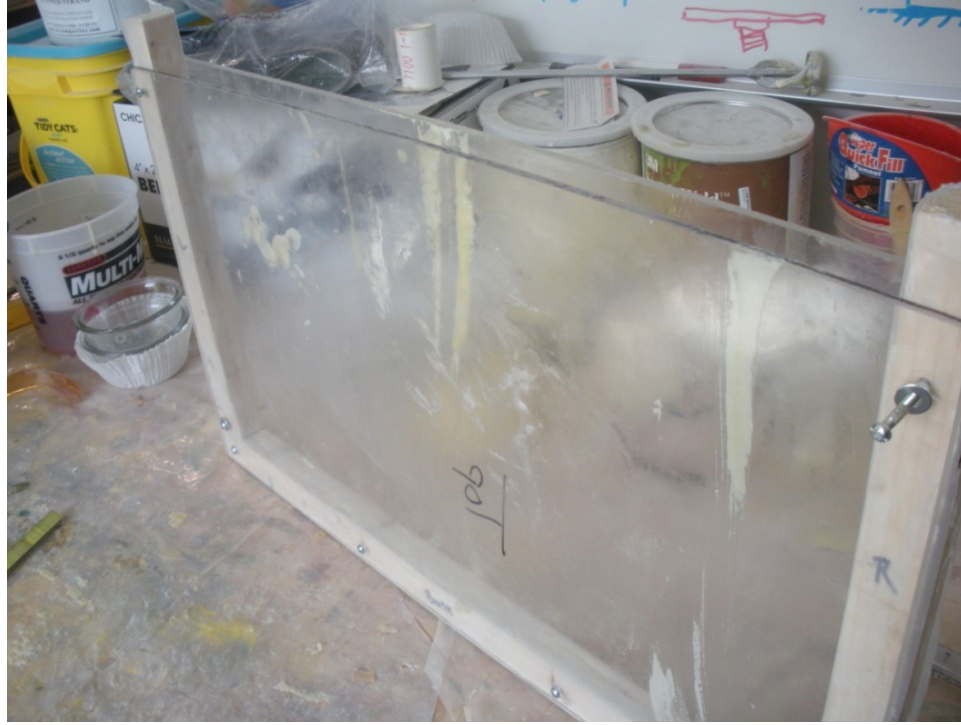
The polyurethane foam was poured into a large flat mold with acrylic glass sides, shown in Figure 3.14. The dimensions of the mold were 40 x 50 x 2.5 cm.

Figure 3.14. Mold for creating rectangular foam

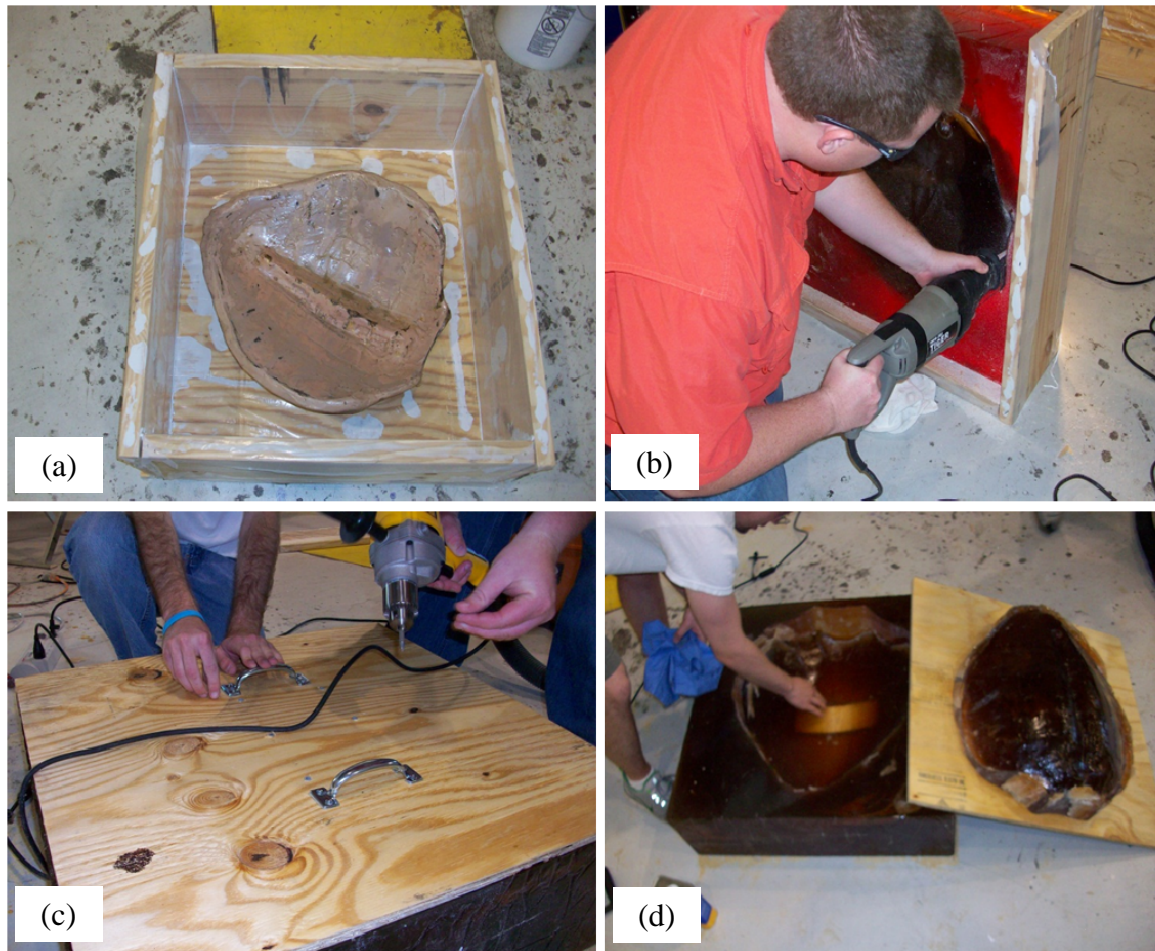
In order to form an artificial carapace in the correct shape, a mold was made of the same turtle carapace that was used as a basis for the synthetic shells produced by Sapp (2010). The mold making process is shown in Figure 3.16. The carapace was coated with automotive body filler on both sides, sanded smooth, and then coated with a urethane finish. The carapace was placed dorsal side down in a wooden box lined with plastic (Figure 3.16a) and then encased in a two-part liquid urethane mold rubber. The

shell was placed on a small wooden riser so that it would be completely surrounded by the mold rubber. The two parts were mixed equally by weight in a bucket and stirred with a paint mixer attachment on a power drill. The bucket was placed on a digital balance, and approximately 9 kg of one part of the mold rubber was poured; then an equal weight of the second part was added. The mixture was stirred for 60-90 seconds and then poured into the box. This process was repeated until the carapace was completely encased in mold rubber. The process was completed quickly to produce a continuous mold that did not separate into layers. The mold used approximately 115 L (122 kg) of mold rubber and was allowed to cure for five days before shell removal. The shell was removed by cutting around the perimeter of the carapace with a reciprocating saw (Figure 3.16b). Once the top (male part) of the mold was removed, plywood and handles were attached to the top of the mold to allow for placement during the shell casting process (Figure 3.16c). The plywood rested on the flat surface of the mold, leaving a void in which the foam carapace formed.

Figure 3.16. Mold construction process: (a) shell in wooden frame (b) cutting out shell from rubber mold (c) attaching lid to male part of mold (d) two halves of mold with shell removed.

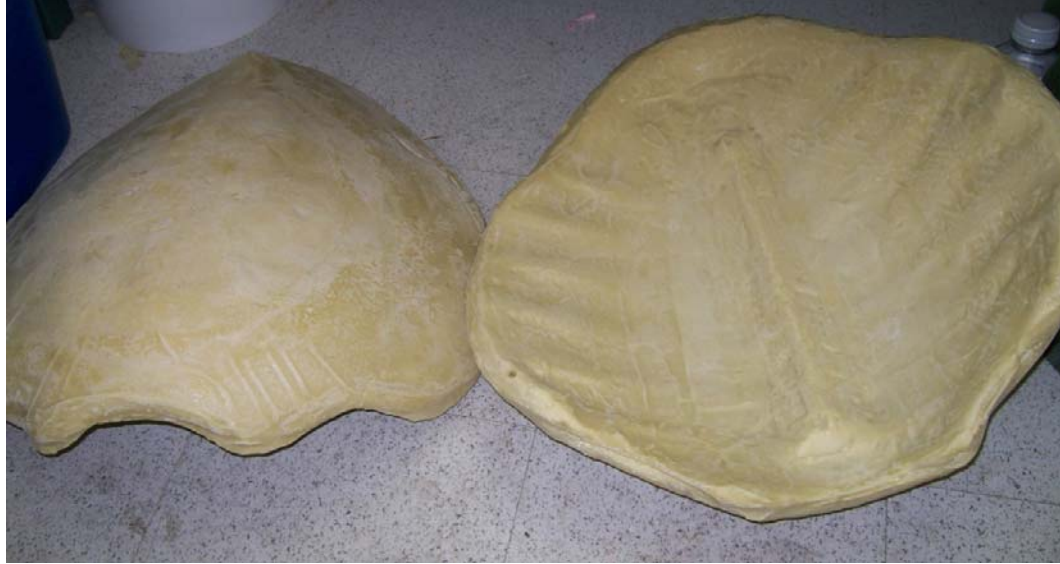
Figure 3.18. Foam carapaces after sanding

allowed to expand through two release holes located at the highest point of the carapace. The shell was left in the mold for 20-25 minutes before being removed. Excess foam and imperfections at the edges were chipped off, and the residue of the release spray was washed off using dish soap. After drying, the shell was sanded to reduce imperfections and to make the shell surface more receptive to the resin during the spraying process. The dorsal and ventral views of the foam carapace are shown in Figure 3.18. The foam shell has a mass of approximately 2.0 kg. A total of 60 foam shells were produced.

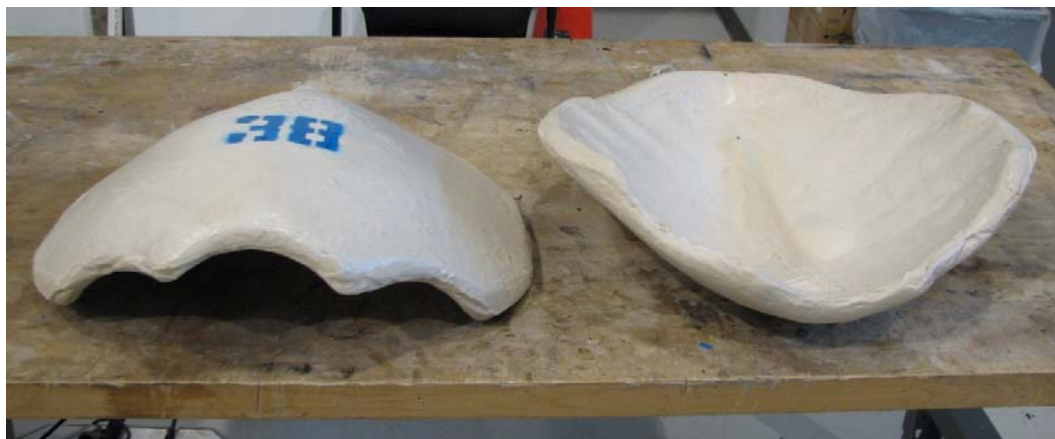
Figure 3.20. Artificial carapaces with resin coating

In preparation for coating with the resin system, the foam carapaces were washed and sanded. The polyester resin with glass microspheres mixture was applied using an air-powered spray gun with a 4.7 mm nozzle opening and an operating pressure of 0.5 MPa. The resin and microspheres were mixed in a 1:1 ratio by volume. The resin hardener, about 1% of the volume of resin, was added to the mixture immediately prior to spraying. The spraying process is shown in Figure 3.19. Three coats were applied to each side, 20-30 minutes apart. The spray gun's metal parts were cleaned with acetone between coats. After three coats had been applied to the inner surface, the shells were placed in a confined space and allowed to cure fully. The remaining side was then sprayed, typically the following day. A total of approximately 235 mL of the resin system was applied to each side of the carapace. The finished shells, shown in Figure 3.20, are white with a glossy finish and weigh 2.8 kg with a curved carapace length of 64 cm.

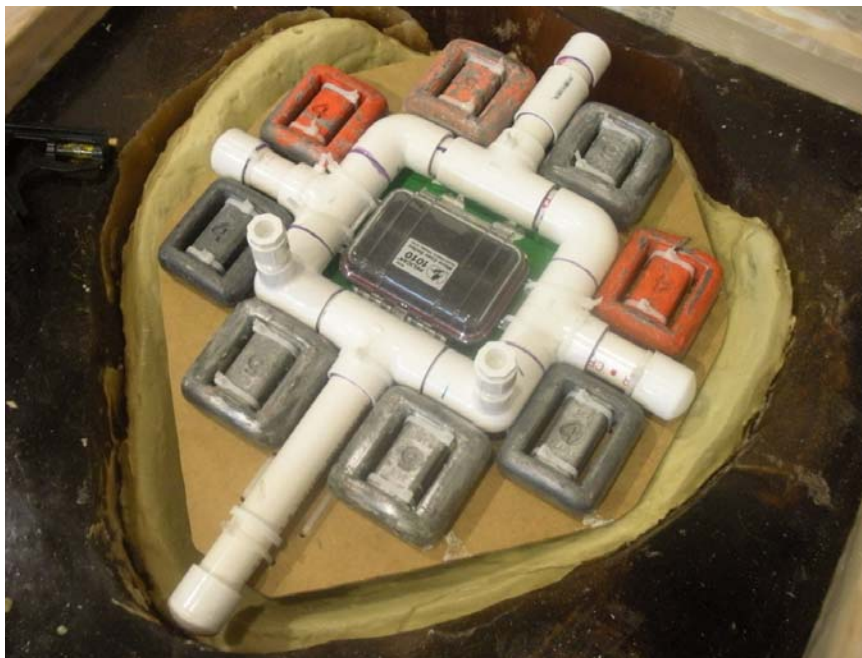
Figure 3.22. Board, PVC frame, and weights resting on shell in mold prior to pouring the foam for the body

The board assembly was encased in 48 kg/m<sup>3</sup> polyurethane foam to provide buoyancy and prevent damage to the materials. Figure 3.22 shows the board, with weights, PVC, and accelerometer housing attached, placed on an uncoated shell inside the mold. The uncoated shell was sprayed thoroughly with mold release so that the body and carapace could be separated after removal from the mold. To completely surround

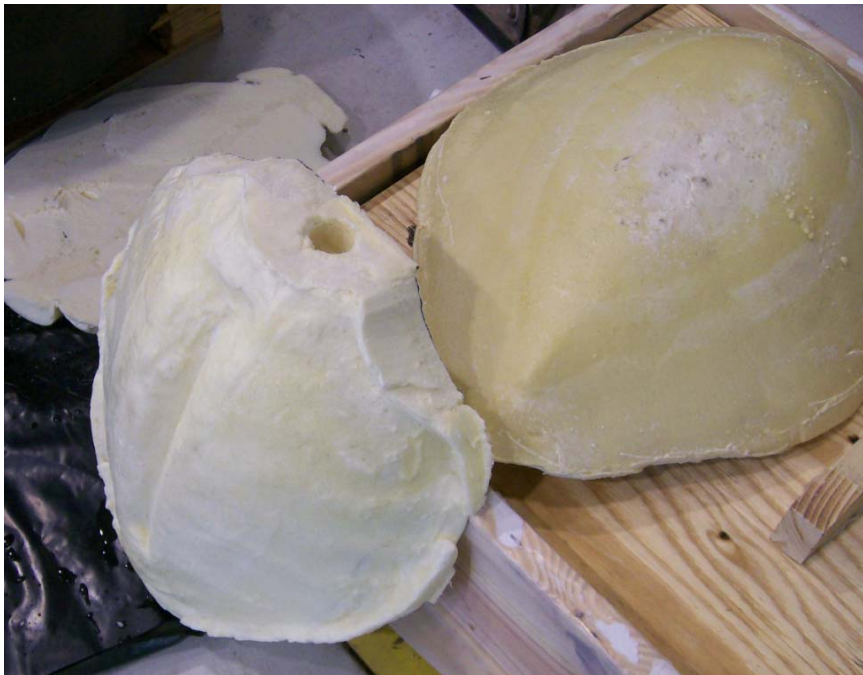
Figure 3.24. The body and foam carapace after separation

After a sufficient amount of foam had been poured, the shell and body were removed from the mold and separated from each other. The excess foam was then cut flat on the bottom surface approximately 2.5 cm from the PVC and weights, and ends were modified to allow attachment of head and tail pieces. The body with the shell removed and the underside cut flat are shown in Figures 3.24 and 3.25.

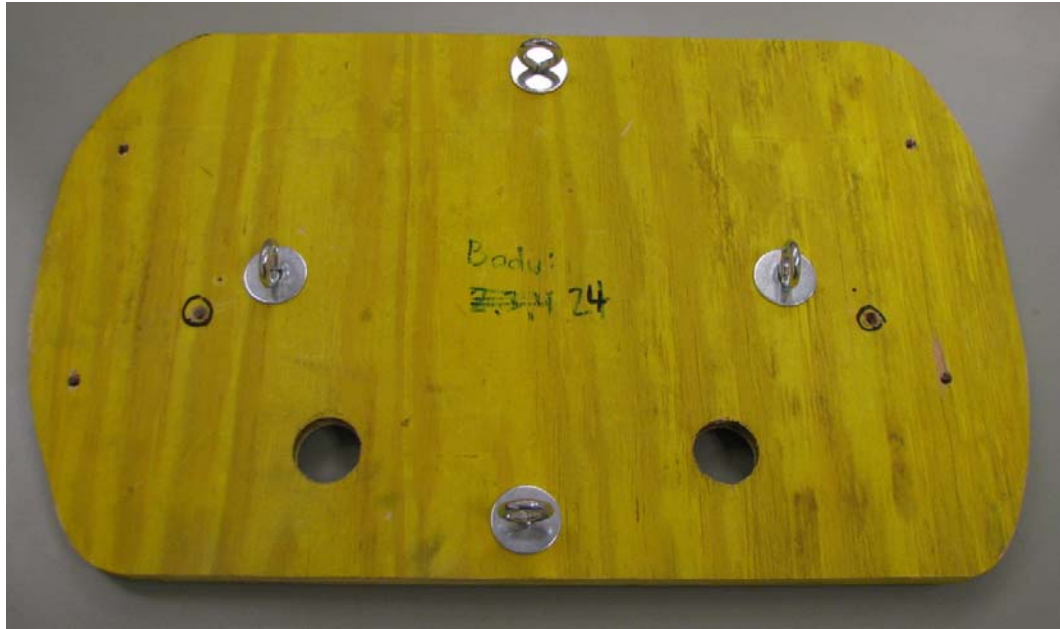
Figure 3.26. Plywood underside with four eye hooks and holes for attachment

A 1.9 cm thick piece of plywood on the underside of the artificial turtle, shown in Figure 3.26, served multiple purposes. Two holes near each edge aligned with holes in the carapaces for attachment with cable ties. Four eye hooks were screwed into the plywood for use in tethering the turtle to the shore with polypropylene ropes. The plywood also protected the accelerometer housing. The board was aligned by placing the two PVC protrusions through large holes in the board. This prevented movement of the board relative to the rest of the body during impact.

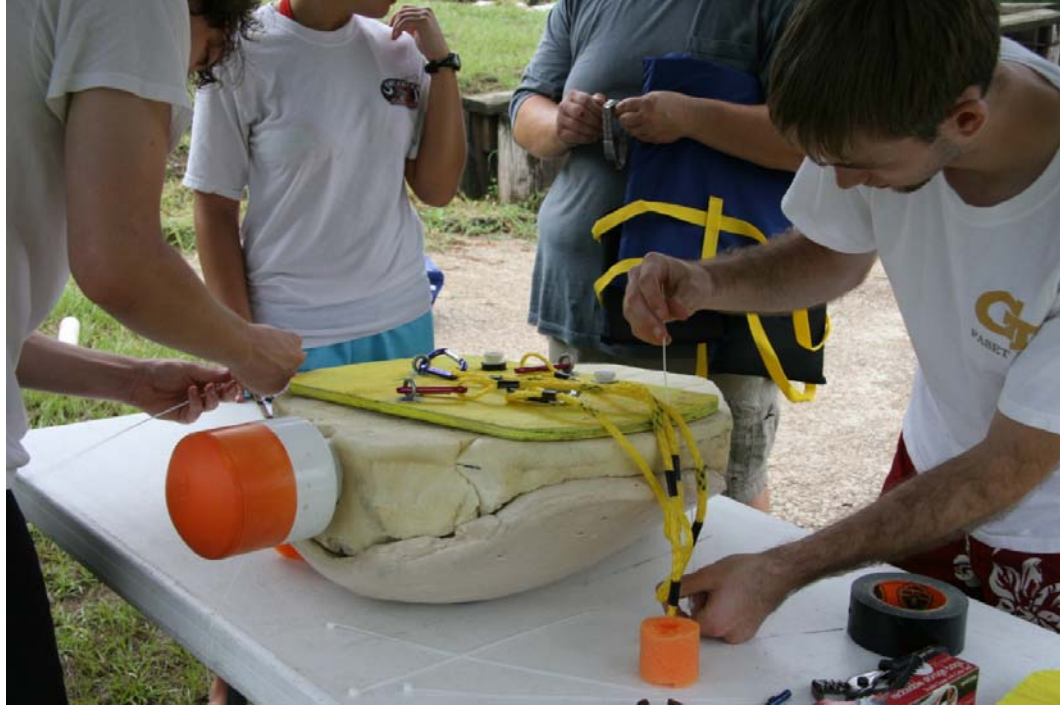
Figure 3.27. Attachment of carapace to body using cable ties

The synthetic carapace was attached to the body at five locations using plastic cable ties – a method similar to the design used in previous field experiments (Sapp 2010; Work et al. 2010). There were two holes on each side of the turtle and one in the rear. The cable tie in the rear passed through the PVC frame, and the holes on the sides passed through the body and the plywood on the underside. This system allowed for the quick removal and attachment of shells between tests, and the body could be used for multiple shells during the course of testing. Figure 3.27 shows the process of attaching a carapace to a body. Five bodies were prepared for the first round of testing. A revised body design, described in Section 4.3.1.1, was used in the second round of field tests.

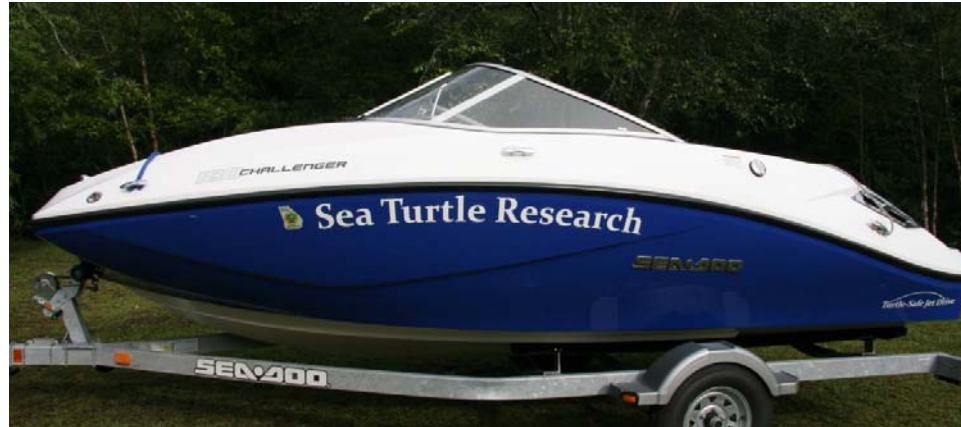
Figure 4.2. Vessel 1, 5.4 m inboard jet propulsion vessel

Testing procedures were designed to investigate the effect of animal position in the water column, vessel propulsion system, and hull shape on the lethality of sea turtle injuries from vessel strikes. Two boats were used in the field experiments: a 5.4 m inboard jet propulsion vessel and a 7.3 m 4-bladed outboard propeller-driven vessel. Both have deep-vee hulls, which is defined as a hull deadrise angle greater than 20 degrees. A steep angle allows the hull to slice through water and waves. The two vessels are pictured in Figures 4.2 and 4.3. Hereafter, the jet boat will be referred to as “Vessel 1” and the propeller-driven boat as “Vessel 2.”

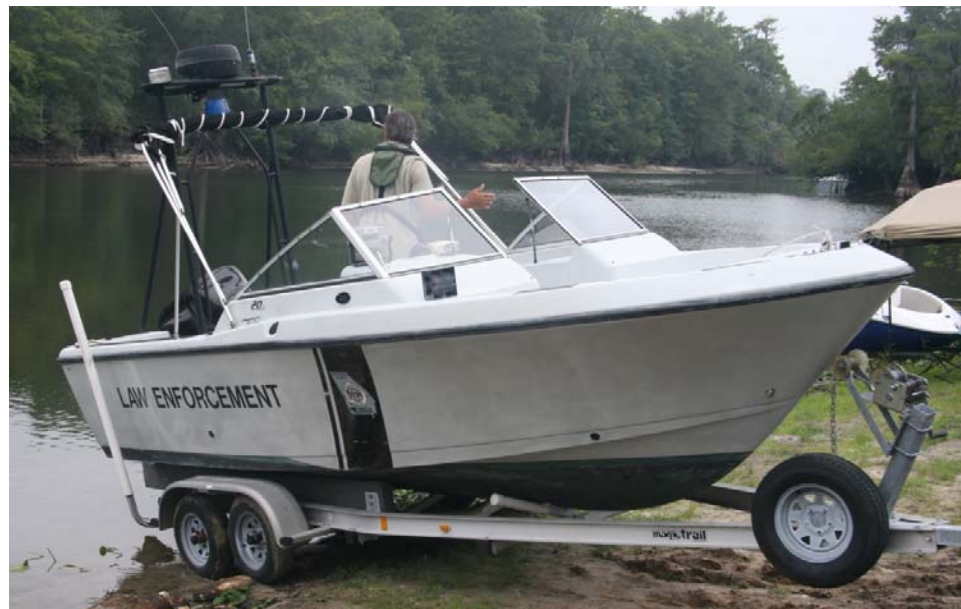
Figure 4.3. Vessel 2, 7.3 m 4-bladed outboard propeller-driven vessel

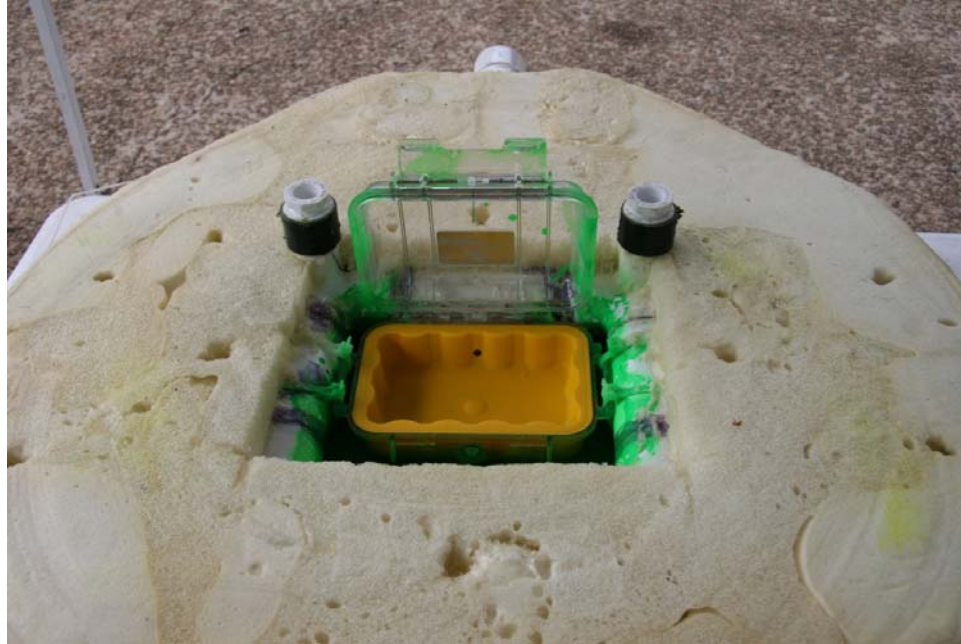
Figure 4.4. Underside of body showing accelerometer housing and PVC extensions

A plastic case on the underside of the body, shown in Figure 4.4, housed the accelerometer/datalogger. The three-axis digital accelerometer has a range of  $\pm 15$  g, an accuracy of  $\pm 0.15$  g, and a sampling rate up to 1600 Hz (MSR Electronics GmbH 2012). The datalogger can store up to two million measurements with installed memory and has a micro-SD slot for memory expansion. The plastic housing was used to prevent damage to the accelerometer from water and impact and provide a rigid base so the accelerometer would not move relative to the turtle during impact. The accelerometer/datalogger was attached to a removable rubber base with three screws and then placed in the plastic case. During testing the accelerometer was placed in a plastic bag for waterproofing. The accelerometer could easily be transferred between turtle bodies between tests. The accelerometer, rubber base, rubber lining, and plastic case are shown in Figure 4.5.

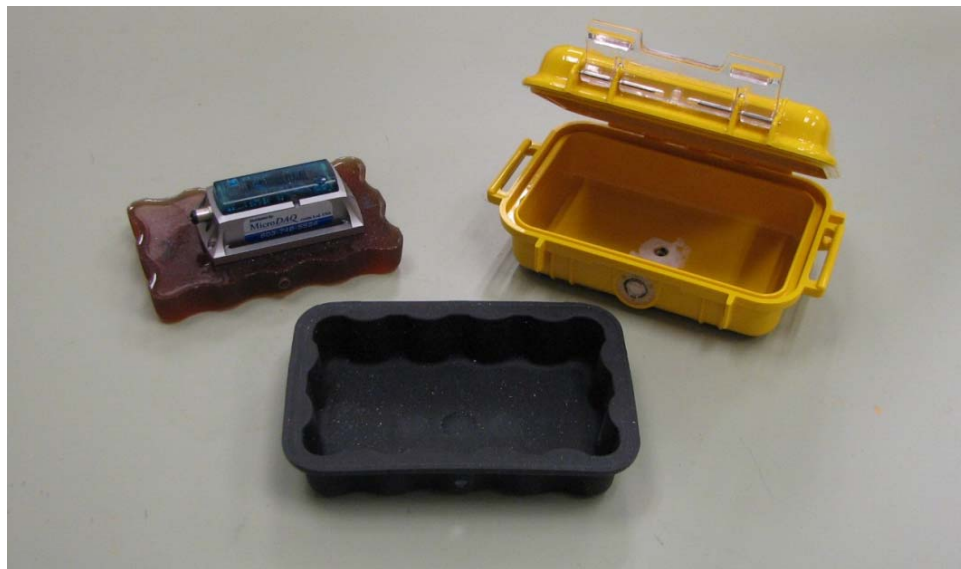
Figure 4.5. Accelerometer with rubber base, lining, and plastic housing

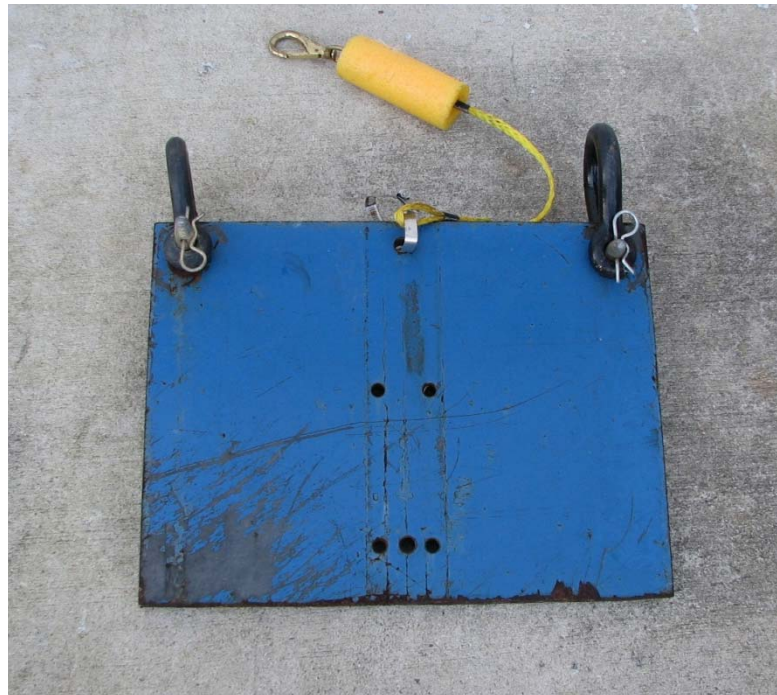
Figure 4.6. Metal anchor with rope and swiveling carabiner

During field testing, the turtle was held in place using an anchor system. A 35 kg metal plate was dropped to the bottom of the river at a depth of approximately 3 m. A short piece of rope with a swiveling carabiner on its free end was attached to the anchor, as shown in Figure 4.6; the tether connecting the turtle to the shore ran through the carabiner. Flotation attached to the carabiner aided in finding it in the event the tether to shore was disconnected. The swiveling carabiner helped prevent ropes becoming tangled and twisted when pulling on the tether from shore.

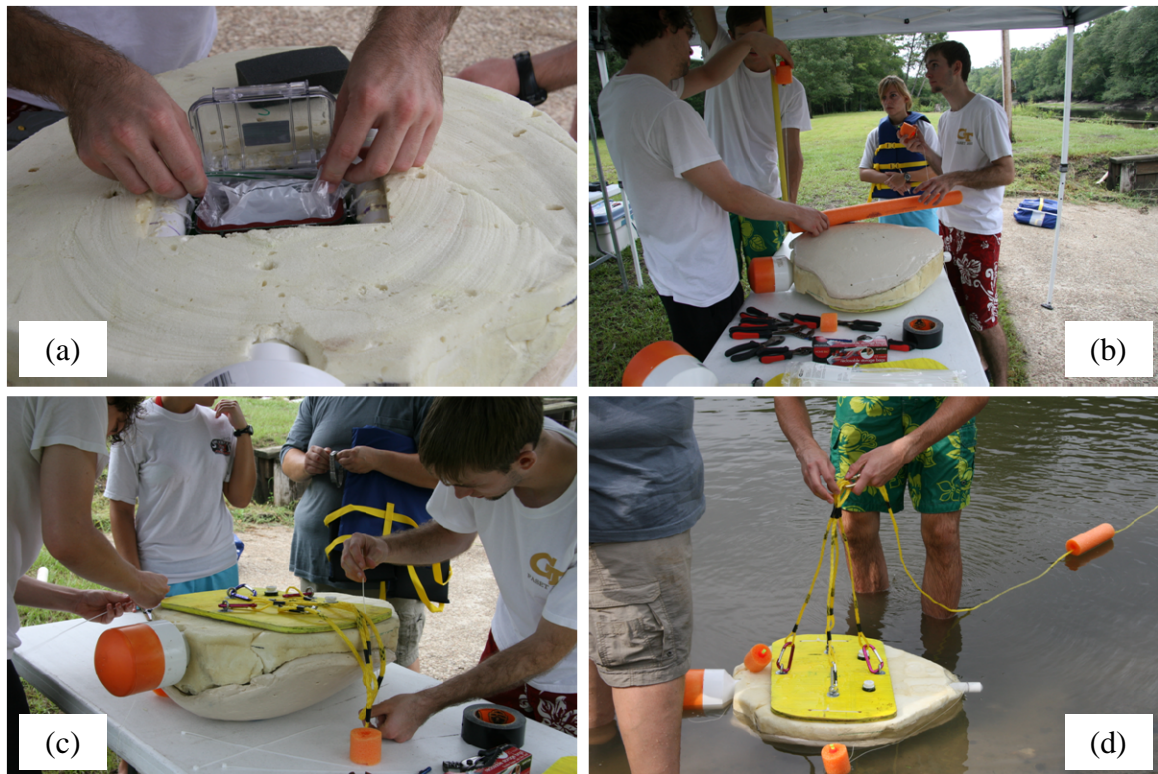
Figure 4.7. Preparation and deployment of artificial turtle showing (a) placement of accelerometer, (b) measurement and attachment of floats, (c) attachment of carapace to body with cable ties, (d) attachment of ropes and tether

Photographs of the deployment process are shown in Figure 4.7. To prepare a specimen for testing, the accelerometer was turned on to record continuously and then placed in its plastic housing (Figure 4.7a). The carapace and plywood were then attached to the body with plastic cable ties (Figure 4.7c). The carapace was also attached in the rear with a cable tie through the PVC frame. If the test was being performed below the surface, small floats were attached to the PVC head and tail pieces at the designated distance above the highest point on the carapace (Figure 4.7b). The floats also aided the vessel operator in seeing the target in the water. Four short ropes of equal length (0.5 m) were attached with carabiners to the eye hooks on the plywood underside, and the turtle was carried to the water's edge. The tether from the shore was then attached to the four ropes, and the turtle was placed in shallow water (Figure 4.7d). If the turtle was not level in the water, small adjustments were made to the length of one of the four ropes or water was allowed to fill the PVC frame to decrease buoyancy.

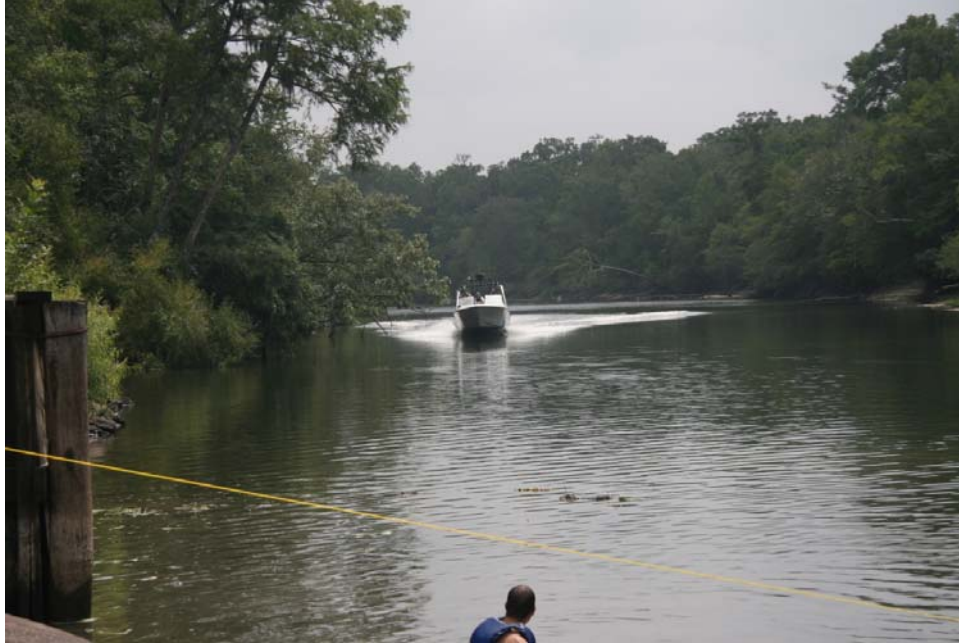
Figure 4.9. View of field test showing approaching vessel

Figure 4.8. Figures 4.9 and 4.10 show views of the test site with an approaching vessel and the line connecting the shore and turtle, which is visible in the water.

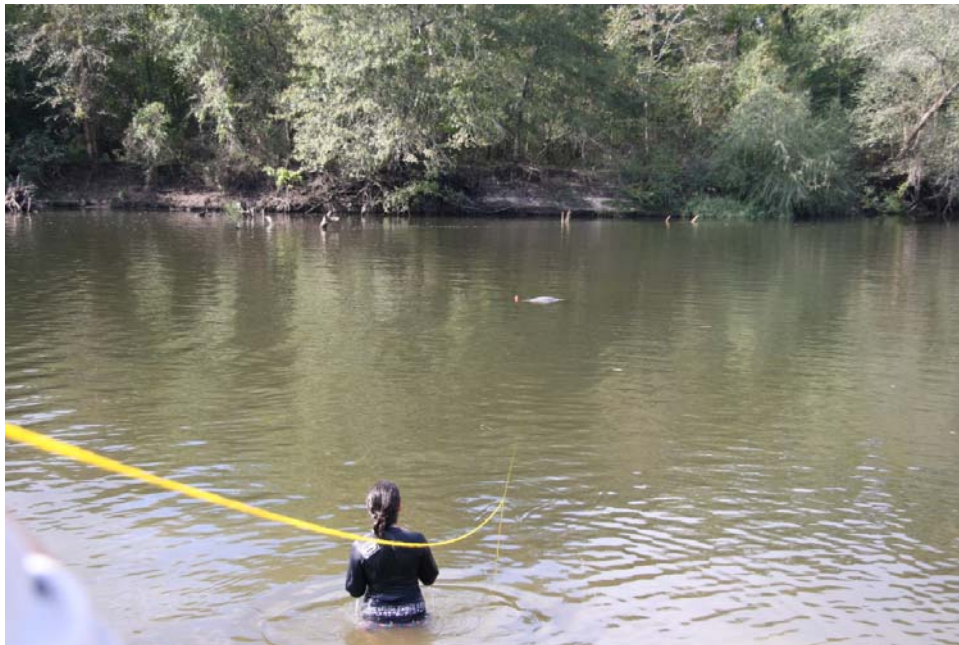
Figure 4.10. View of field test showing turtle in water and tether from shore

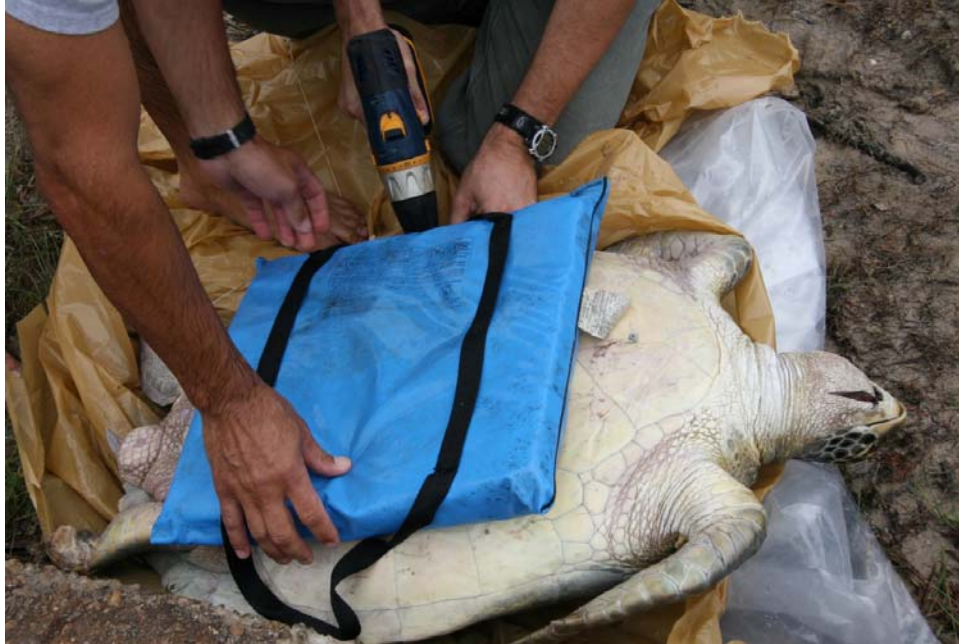
Figure 4.11. Attachment of flotation directly to a real turtle plastron

The GDNR provided eleven deceased sea turtles for vessel strike testing. All the turtles were cold-stunned deaths that had been kept frozen at GDNR facilities. The sea turtles were thawed at the site before conducting the field experiments. Only one of the eleven was a loggerhead; the rest were green sea turtles. The real turtles were deployed in the water in a similar manner to the artificial turtles. Screws were placed directly in the plastron for attaching the tether. To provide buoyancy, flotation from life jackets was attached to the underside of some specimens, as shown in Figure 4.11. The shells were painted red to improve visibility in the water, as shown in Figure 4.12.

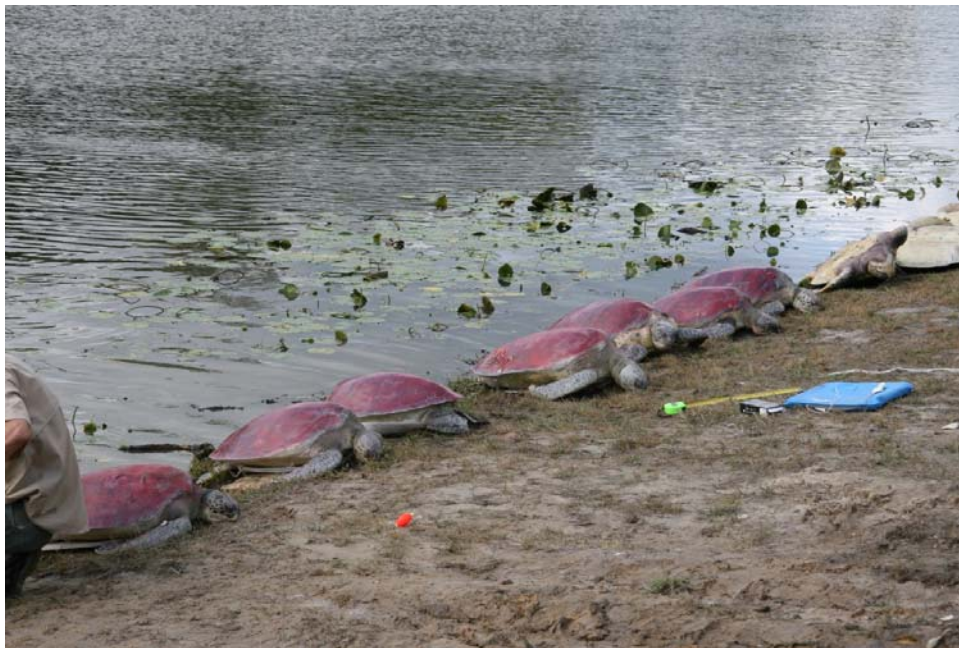
Figure 4.12. Real sea turtles prior to field testing with shells painted red

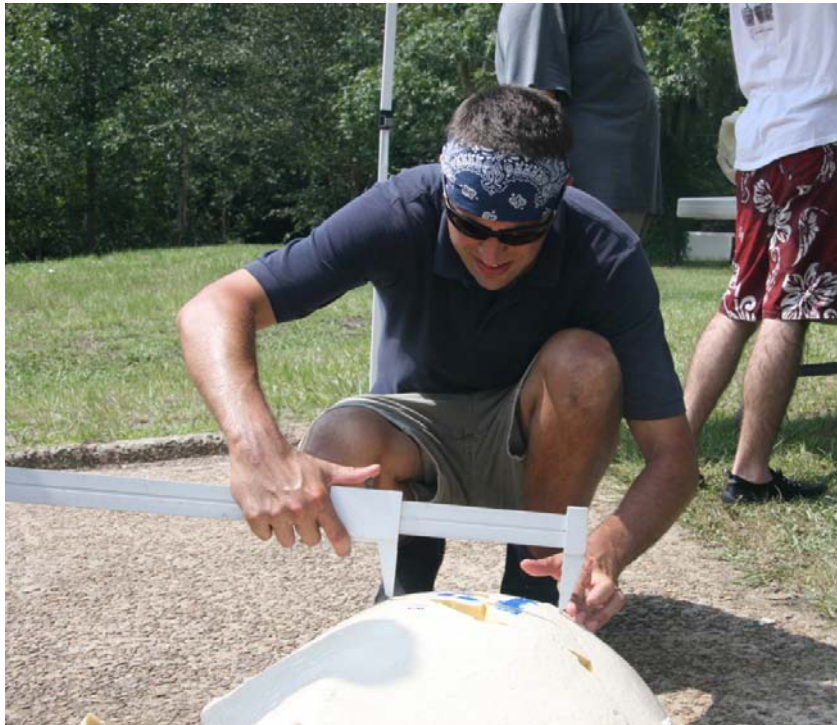
Figure 4.14. Measurement of wound length and spacing after field testing

After recovery of the turtle, photographs and measurements of the damage pattern, including depth and spacing of wounds, were taken. Measurements were made with a set of calipers, as shown in Figure 4.14. Metal discs of varying sizes were placed in the propeller wounds to estimate the diameter of the propeller size on the vessel, as shown in Figure 4.15.
